LASER INDUCED REACTION FOR PREBOND SURFACE PREPARATION OF ALUMINIUM ALLOYS

Stage 3 report (7-10/93)
Contract No. F61708-93-C005

M. Rotel, J. Zahavi
Israel Institute of Metals, Technion, Haifa, Israel

A. Buchman, H. Dodiuk
Materials and Processes Department,
RAFAEL, Haifa, Israel

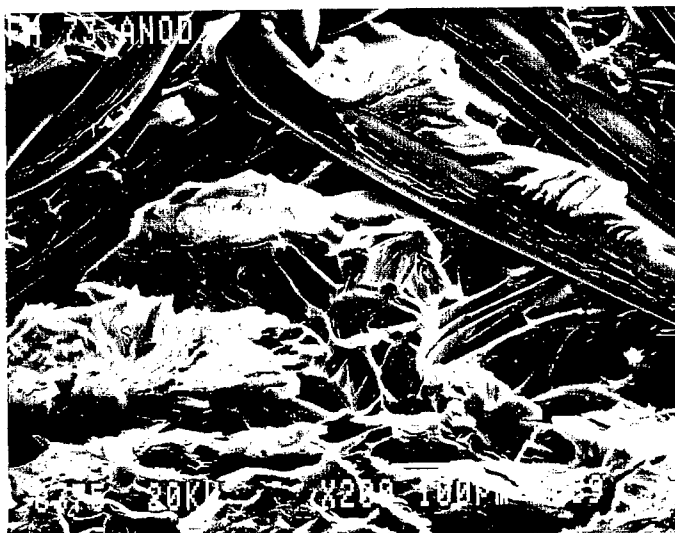
Fig. 3.1: SEM photographs of the surface failure morphology of SLS tests (table 3.1) with adhesive FM73, primer BR127. a: without treatment. b: anodized adherends.

Figs. 3.1-3.7 show the morphology of the failure surface of the shear joints the strength of which were summerized in table 3.1.

The cohesive failure is localized within the adhesive. The carrier net and the matrix adhesive are present on both surfaces.

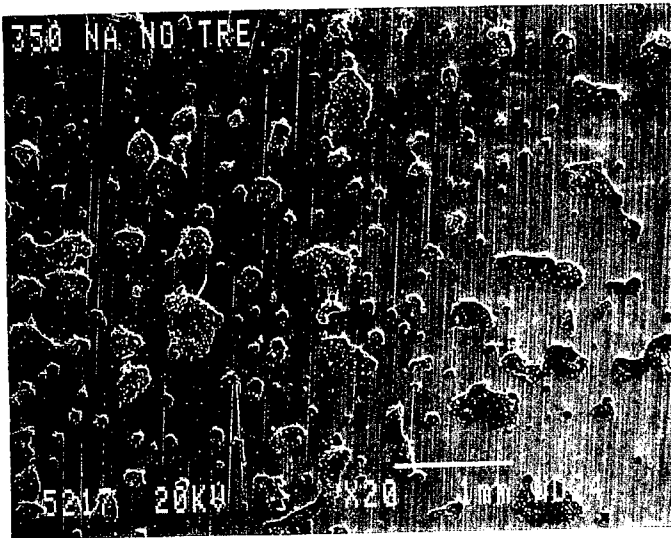
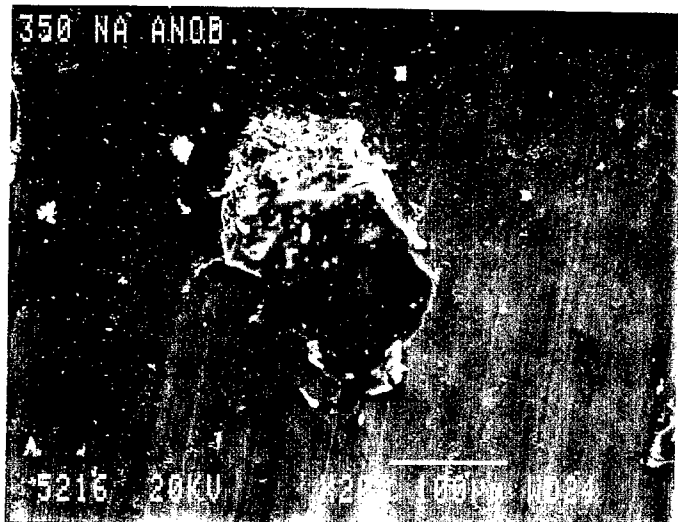
Fig. 3.8: SEM photographs of the surface failure morphology of SLS joints (table 3.3) with adhesive FM350NA, primer A187. a: without treatment. b: anodized adherends.

Figs. 3.8 -3.11 show the failure surface morphology of SLS adherends of joints bonded with FM350NA and primer A187. Comparison between the cohesive failure of the anodized adherends and the adhesive failure of the untreated adherends is shown in fig.3.8.

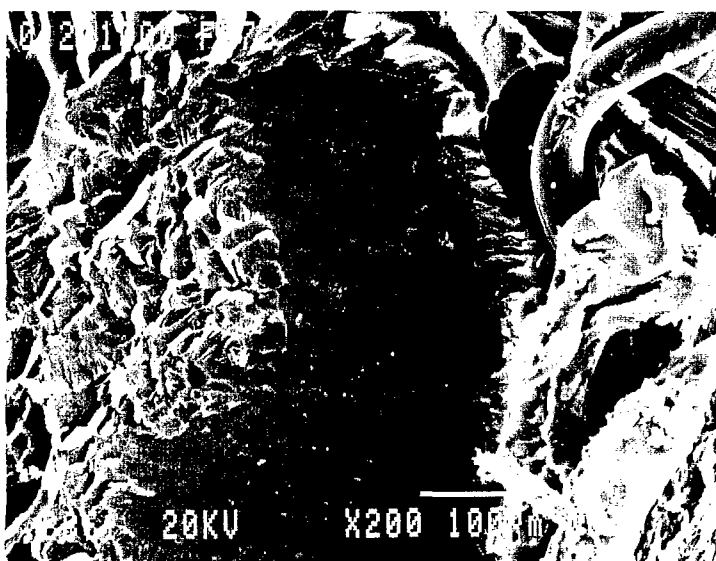
Fig. 3.12: SEM photographs of the surface failure morphology of SLS joints (table 3.4) with adhesive FM73, fresh primer BR127, laser energy $180\text{mj/p}\cdot\text{cm}^2$, 1000 pulses.

Experiments with a fresh BR127 primer and the adhesive FM73 (table 3.4) show that laser treated joints have shear strength similar to those with the primer A187 (329 Kg/cm²). Figs 3.12-3.13 show the cohesive failure mode of laser treated joints bonded with fresh BR127 and FM73. Experiments without a primer (table 3.5) and with an adhesive FM73 show shear strength of 321 Kg/cm². These results prove that the main effect of the surface treatment and improve adhesion strength arise from the laser irradiation while the primer has only a minor effect.

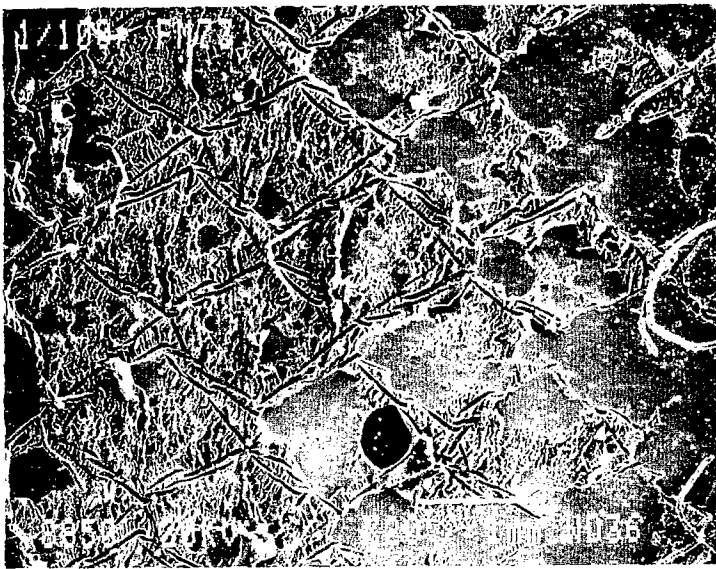
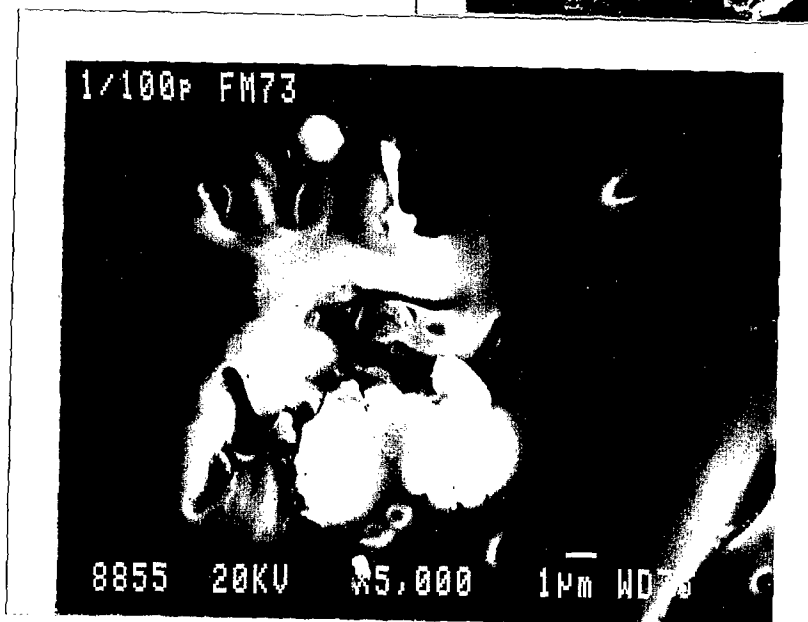
Fig. 3.13: SEM photographs of the surface failure morphology of SLS joints (table 3.4) with adhesive FM73, fresh primer BR127, laser energy $1\text{J/p}\cdot\text{cm}^2$, 100 pulses.
